Webster Lake Engineering Feasibility Study

KOSCIUSKO AND WHITLEY COUNTIES, INDIANA

May 18, 2004

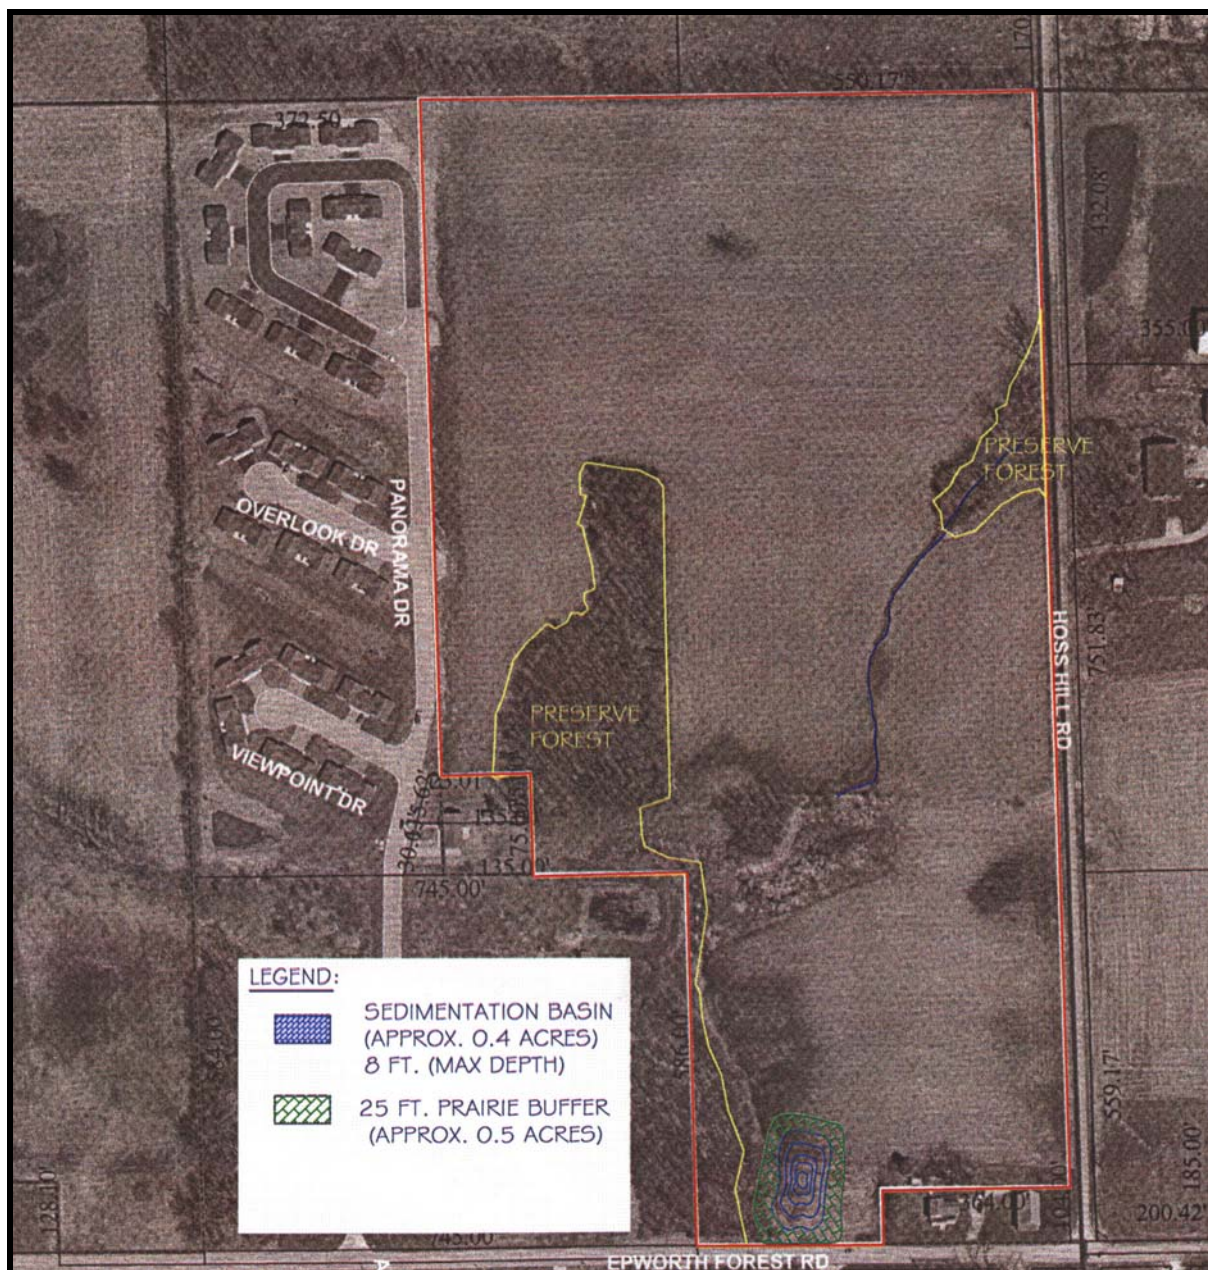
Figure 6. Sedimentation basin plan view.

A sedimentation basin approximately 0.4 acres in size surrounded by a 25-foot wide prairie buffer is proposed in the southwest corner of the property (Figure 6). The basin will serve as a sediment and sediment-attached pollutant collection basin and will store stormwater runoff from the approximately 30-acre watershed. The sedimentation basin will collect water from both overland flow and subsurface tile flow. The basin will receive subsurface discharge from the existing drainage tile on the parcel. The final design should designate a permanent pool elevation equal to the invert of the existing drainage tile and a bottom depth eight feet below permanent pool level. A water level control structure installed at the downstream end of the sedimentation basin will increase retention time during high flow events, allowing more time for suspended sediments and sediment-attached pollutants to drop out. Water will exit the sediment basin through a pipe to be connected to an existing pipe under Epworth Forest Road. The existing pipe discharges to an unnamed stream that flows into a channel on Webster Lake. The prairie buffer will provide wildlife habitat; reduce sheet, rill, and gully erosion around the basin; and filter pollutants from surface water prior entering the basin. The project could potentially be expanded to replace the drainage tile that connects an area where water currently ponds to the residential area on the south side of the Epworth Forest Road that could alleviate the residents' flooding concerns. The project could also be expanded to replace the open unnamed stream on the south side of Epworth Forest Road with a pipe or tile. This could eliminate a majority of debris and waste that is currently placed in the open ditch from entering Webster Lake.

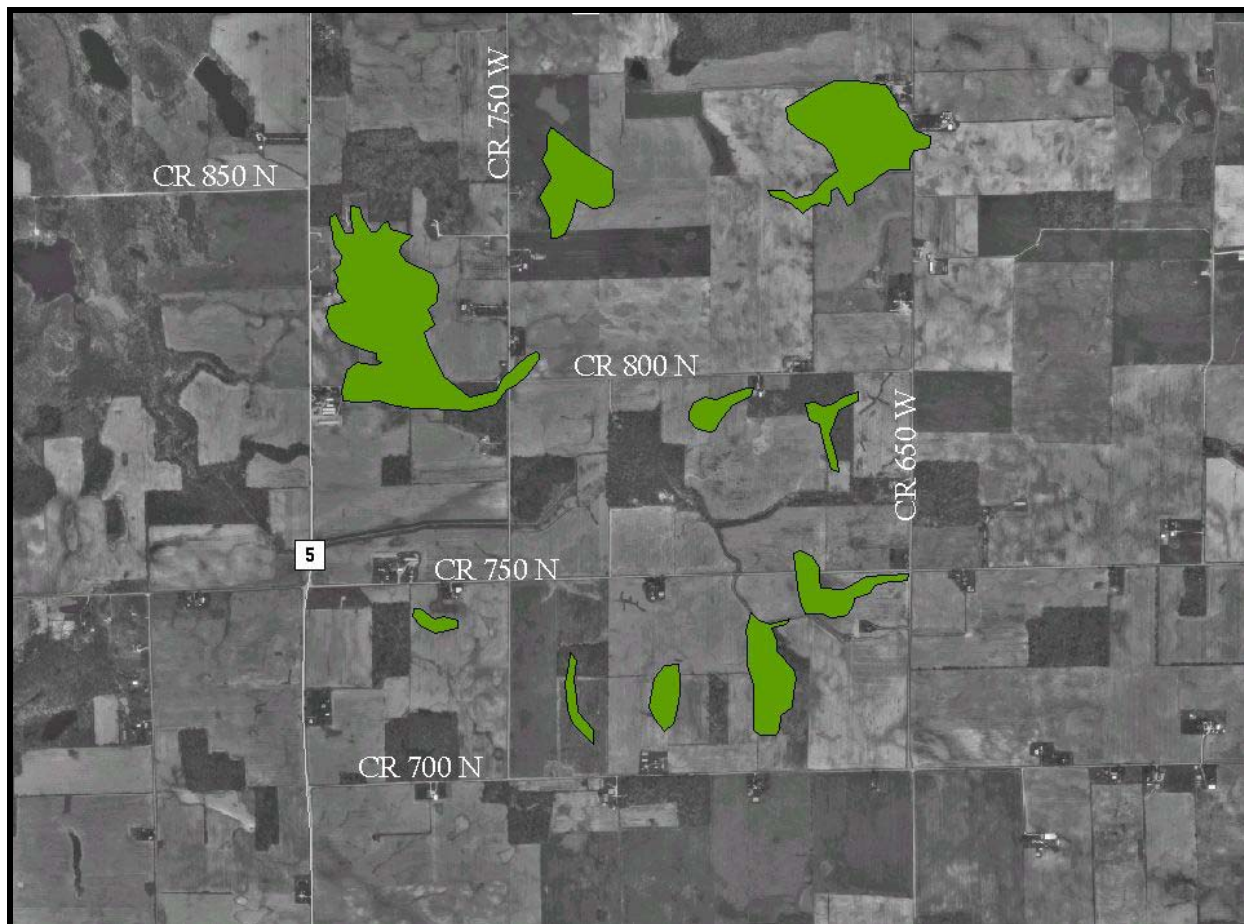
Figure 9. Potential wetland restoration sites identified in the Gaff Ditch headwaters.

Using recent aerial photographs and the Kosciusko County Soil Survey, ten potential wetland restoration sites were located within the project area (Figure 9). JFNew contacted each of the landowners associated with potential restoration areas. Concurrently, JFNew met with Amy Lybarger of the Whitley County Natural Resource Conservation Service (NRCS) and two

landowners to discuss potential wetland restoration sites. Through this process, all of the potential wetland restoration sites were eliminated due to restoration in progress or already completed on the sites, parcel enrollment in the Wetland Reserve Program (WRP) or other conservation program, or landowners desire to keep the parcel in production.

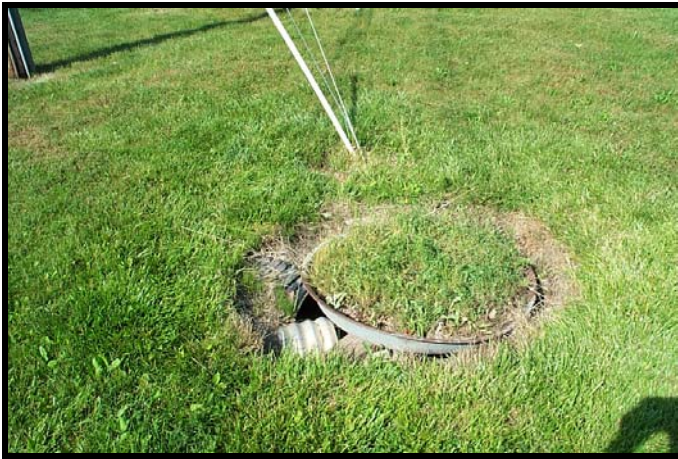
Drain 19: Drain 19 is located at the bend near 100 EMS Lane W30A1 on the northwest side of the road. The drain's inlet is currently a hole in the yard where three drain pipes converge. The landowner has covered the hole with a planter measuring 2 feet in diameter. Three 8-10 inch corrugated metal pipes converge at this point from the southwest, southeast, and northeast. The southwestern pipe is a 10-inch pipe which runs southwest along W30A1 draining yards adjacent to the lake. The southeastern pipe is an 8-inch pipe which runs underneath W30A1 collecting water from yards and the road opposite the lake. The northeastern pipe is a 10-inch pipe which passes underneath W30A1 and collects yard and road drainage from opposite the lake. A 12-inch corrugated pipe runs approximately 200 feet northwest from the convergence to Webster Lake. The outlet pipe is partially blocked with leaves and grass clippings; however, water can exit through the concrete seawall with little difficulty.

Catch basin for Drain 19.

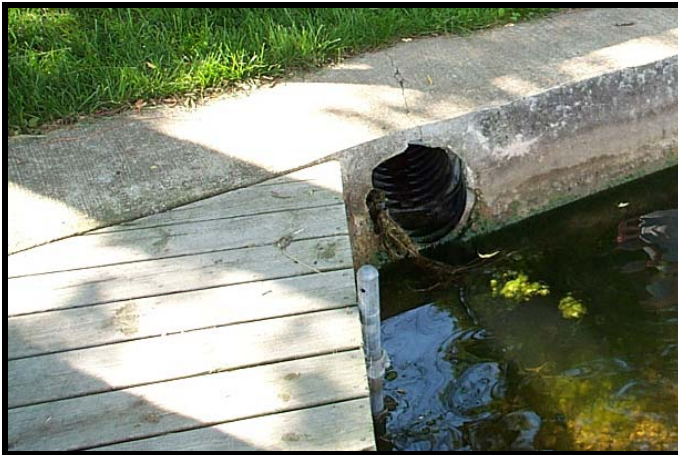
Outlet pipe for Drain 19 at Webster Lake.

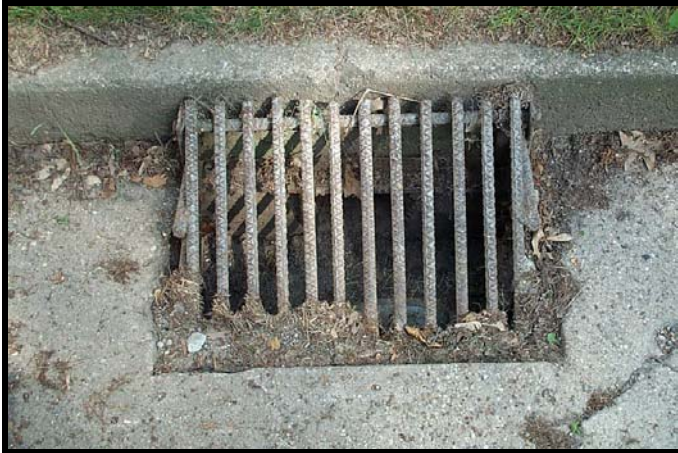
Grated inlet at Drain 20.

Drain 20: Located at 197 EMS Lane W30A1. The inlet to Drain 20 is on the northwest side of the road west of the driveway. Drain 20 has a 1-foot by -foot rectangular grated inlet. The drain accepts water from a 6 inch plastic pipe coming from the southeast. Water exits the drain through a 6 inch plastic pipe which passes on the northeast side of the house and carries water approximately 250 feet northwest to Webster Lake. The pipe empties water from behind a shrub onto a concrete swale. Water then passes from the swale over the seawall before entering the lake.

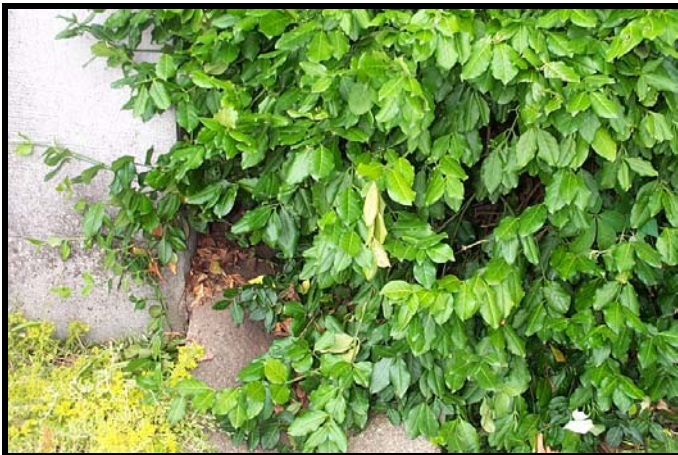
Outlet pipe (behind bush) for Drain 20 at Webster Lake. Water passes from the swale over a seawall and into Webster Lake.

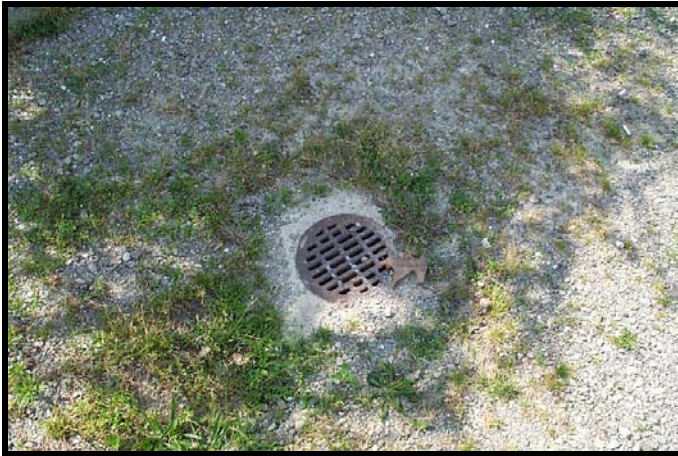
Drain 21: Drain 21 is located at 51 Lane W29B on the south side of the road near the west edge of the driveway. The drain inlet has a 12-inch round grated drain. The drain accepts water from a 4 inch plastic pipe from the southeast. Another 4-inch plastic pipe exits the drain flowing south toward Webster Lake. An outlet at the lake could not be located at the time of the field survey. It is believed that when the timber seawall was constructed the pipe was blocked. Rill erosion adjacent to W29B suggests that water runs along the road during storm events; however, there did not appear to be evidence that water typically ponds in or near the driveway, so the drain may still be functioning in some capacity.

Grated inlet to Drain 21.

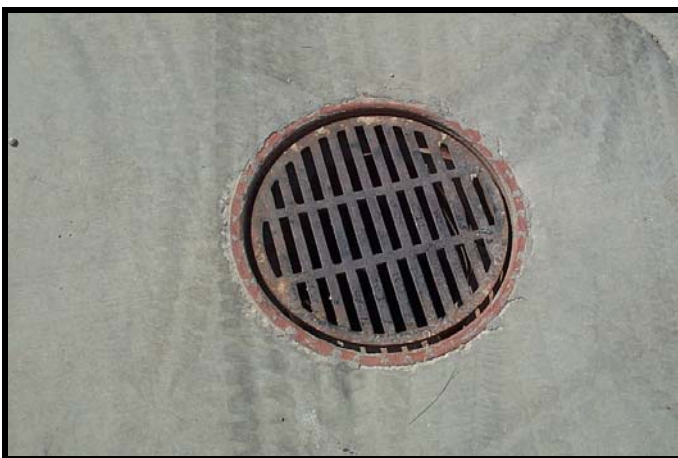
Drain 22: Located at 32 W29B on the south side of the road near the northwest edge of the driveway. The drain's inlet is a 12-inch circular grated cover in a concrete driveway. No inlet pipes could be identified at this drain. A 4-6-inch plastic pipe exits the drain to the southeast running nearly 100 feet to the lake. An outlet pipe could not be located at the lakeshore; a newly constructed concrete seawall is likely blocking the pipe's exit at Webster Lake.

Grated inlet to Drain 22.

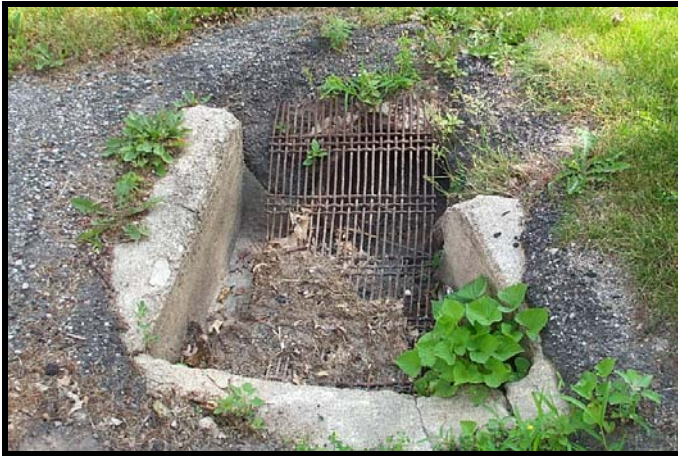
Drain 23: Drain 23 is located at the top of the hill east of the intersection of Lanes W30A1 and W29B. The drain's inlet has a 1-foot by 2-foot grated rectangular cover. Water collects in a gravel drainage channel which runs southeast along W29B before entering an 8 inch plastic pipe. The drain also accepts water from an 8-inch plastic pipe from the east. Water exits the drain through an 8 inch metal pipe. Somewhere between the outlet of the catch basin and the outlet at Webster Lake the pipe has been replaced with a 4-6 inch plastic pipe. The exact location of the change in pipe size and material could not be determined during the field survey. In total, the water runs approximately 150 feet northwest before emptying into Webster Lake.

Grated inlet for Drain 23.

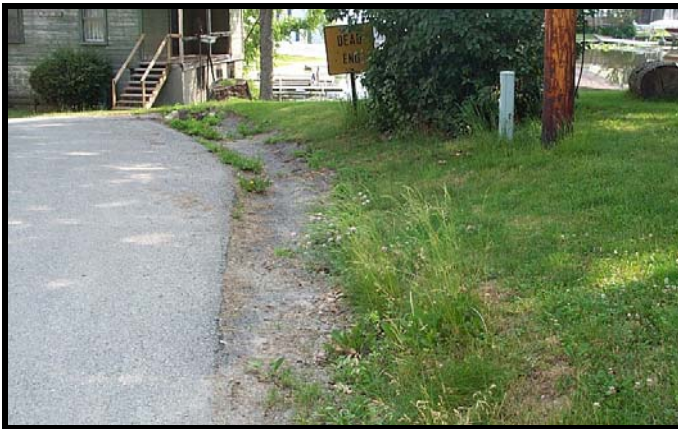
Drainage channel along southeast side of W29B adjacent to the road.

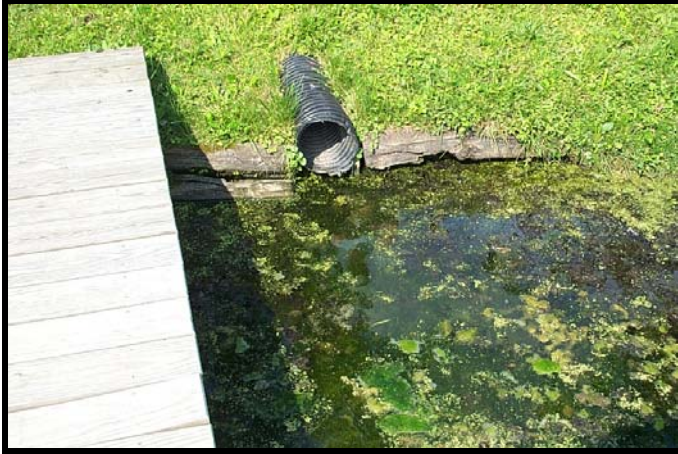
Outlet pipe for Drain 23 at Webster Lake.

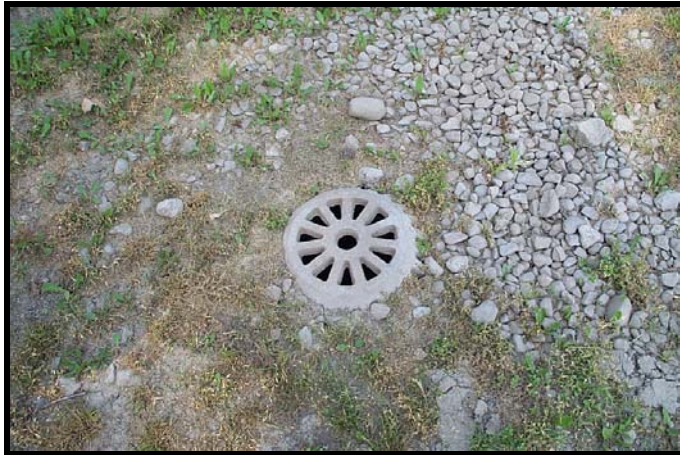
Drain 24: Drain 24's inlet is located in a gravel area between 27 and 35 EMS Lane W26 on the west side of the road. The inlet has a 12-inch cement grated cover. The exact location of pipes entering the drain could be seen during the time of the field survey. It is believed that a 4-6-inch plastic pipe exits the drain to the west. The pipe runs nearly 200 feet before ending at a channel to Webster Lake. The outlet of the pipe could not be located; however, a landowner in the area indicated that she had observed water flowing from underneath the lake-side dock during storm events. The pipe's outlet could not be located underneath the structure; however, a large pile of loose sediment, grass clippings, and leaves were piled underneath the structure at the time of the survey.

Grated inlet to Drain 24.

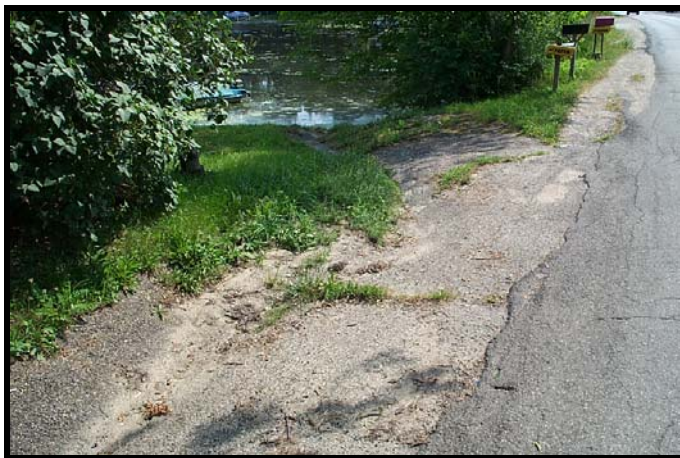
Drain 25: Water drains from the hill at the top of Backwaters Drive into a cement and gravel swale. The swale directs water from the north side of the road away from the roadside, behind a set of mailboxes, down the hill adjacent to the lake, and into the channel between the Backwaters and Webster Lake. The landowner from across the road indicated that water in this drain is typically flowing very fast during storm events.

Cement and gravel swale adjacent to Backwaters Drive near CR 900 East.

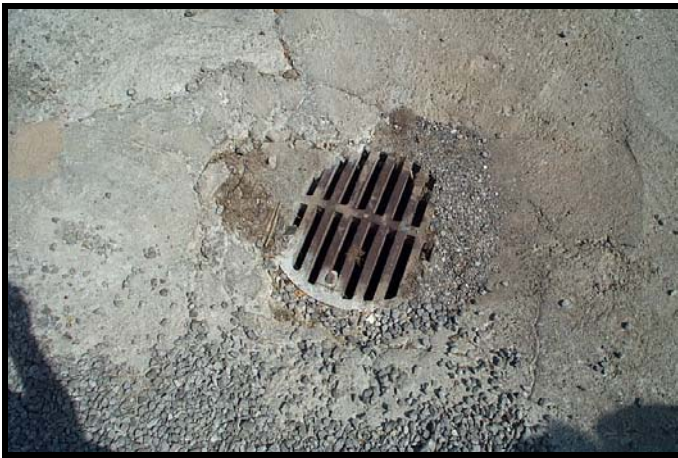
Drain 26: Drain 26's 14-inch grated inlet is located at the end of EMS W23 in the center of the road. The inlet is cemented into the road. This drain receives overland flow from a 4-6-inch plastic pipe which drains the northern section of CR 900 East before running 25 feet down the hill to the west of the drain. Drain 26 receives overland flow from the hill on W23, the hilly area along Backwaters Drive, and the property at the end of the W23. The tops of two pipes could be seen through the grate opening, but their exact location and drainage areas could not be determined due to an accumulation of sediment, grass clippings, and leaves in the drain's catch basin. A metal pipe of indeterminate size flows 75 feet east emptying into a vegetated area in The Backwaters. The owner of the property at the end of W23 indicated that the drain receives large amounts of water during storm events, and typically, "coffee colored" water flows from the drain pipe into the Backwaters. He indicated that water does not normally pond at the end of the road during storm events but that the drain receives a lot of water.

Grated inlet to Drain 26.

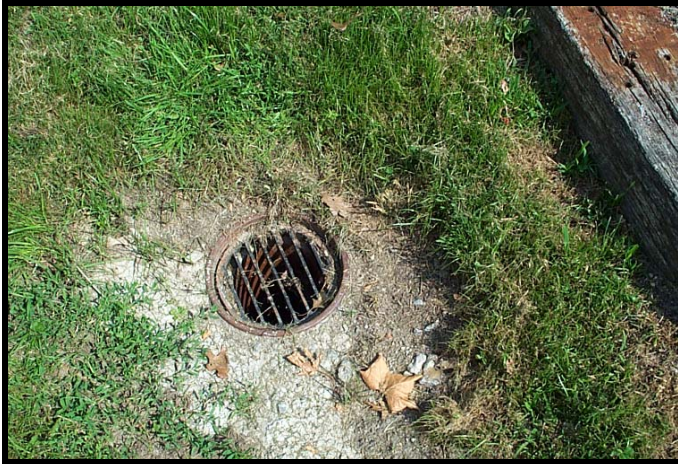
Grated inlet to Drain 27.

Drain 27: The drain's inlet is located at 144 EMS Lane 23A. The drain's inlet is covered by an 8-inch grate. Water flows from across and along the road before entering the drain. A 10-inch plastic pipe exits the drain and flows northeast approximately 50 feet into The Backwaters. The landowner indicated that he built the drain less than a year ago. Despite the storm drain, water still ponds in his driveway and around his house. The landowner requested information and indicated that he would contact Dawn Meyer or Lynn Stevens to attempt to improve the current situation.

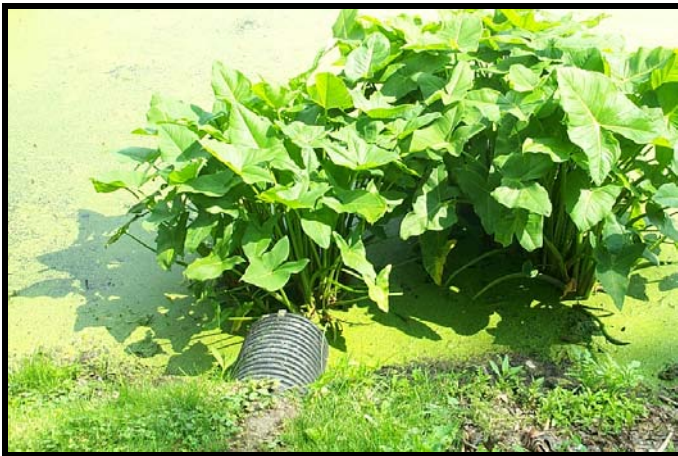
Outlet to Drain 27 at The Backwaters.

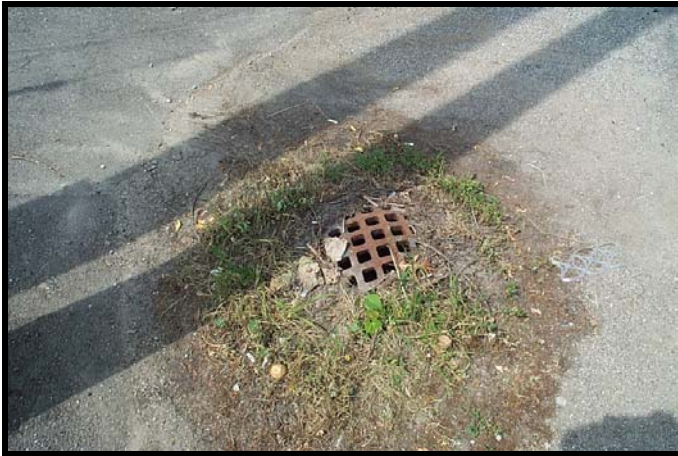
Drain 28: The drain is located at the IDNR Public Access Site along the south side of Backwaters Drive. The 24-inch grated inlet is nearly two-thirds covered in gravel, grass, and leaves. It could not be determined at the time of the survey the exact number of pipes, if any, that connect to this drain. A 12-inch corrugated metal pipe exits the drain to the east running approximately 75 feet under the parking lot before emptying into a marshy area adjacent to the parking lot and Backwaters Drive. The pipe drops water approximately 5 feet into the water. Erosion is likely not an issue here due to the abundant vegetation at the pipe's outlet which limits the velocity with which the water impacts the adjacent shoreline.

Grated inlet to Drain 28.

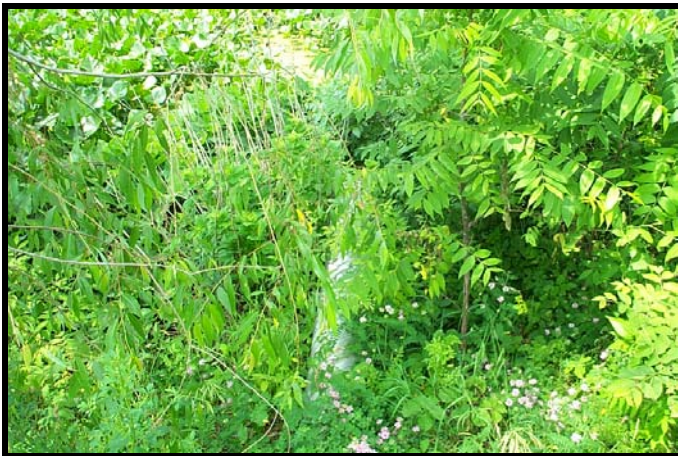
Outlet pipe from Drain 28 to The Backwaters.

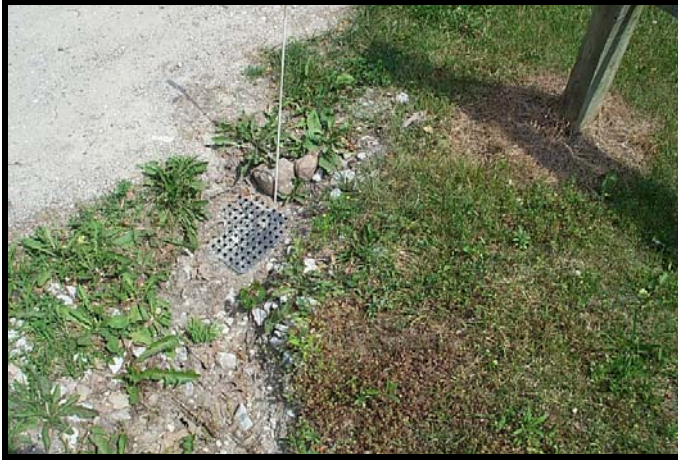
Drain 29: The drain's inlet is located at 400 EMS Lane W19. The drain's inlet is currently an 8-inch by 8-inch square grated inlet. The grate is partially covered by leaves, dirt, and grass. The drain receives water from a 6-inch metal pipe which flows underneath W19 from a drainage channel running along the east side of the road. A 6 inch metal pipe exits the drain flowing approximately 25 feet west toward Webster Lake. Water leaves the pipe and flows as overland flow through the yard, down the slope, and into Webster Lake.

Grated inlet to Drain 29.

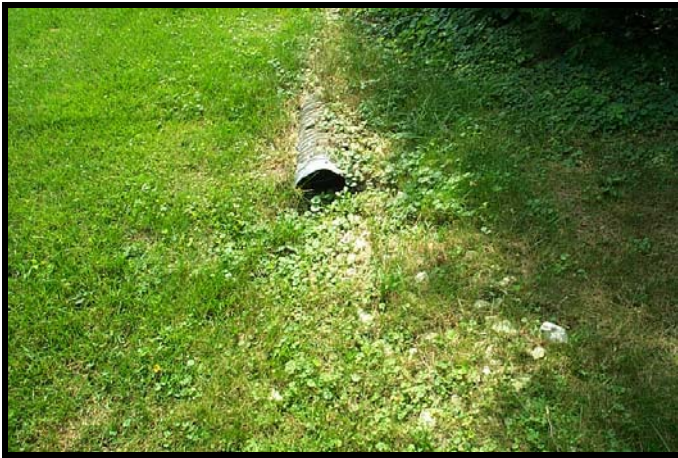
Outlet pipe from Drain 29.

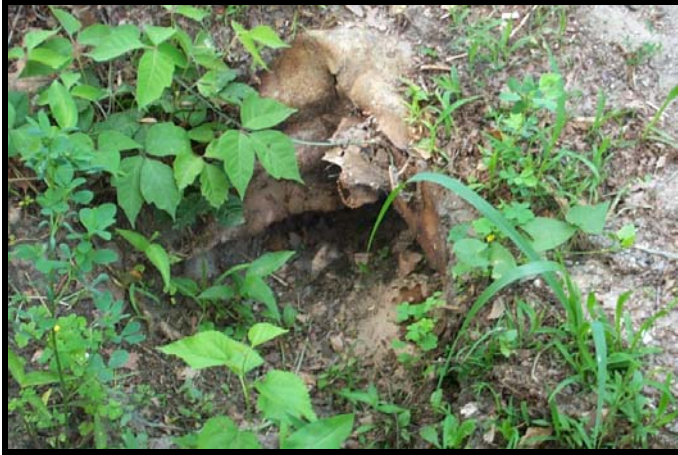
Drain 30: The drain is located at EMS Lane W19 opposite Lane W19A. A road side drainage channel collects water from the east side of W19 directing it into a 12-inch corrugated metal pipe and underneath the road. The pipe which flows under the road is partially blocked with sediment and leaves. The receiving pipe is buried underground and runs down the hill approximately 200 feet to Webster Lake. The outlet of the pipe at the lake shore could not be accurately pinpointed; however, a pipe exiting the hill south of W19A may be the outlet pipe.

Inlet to Drain 30 east of W19.

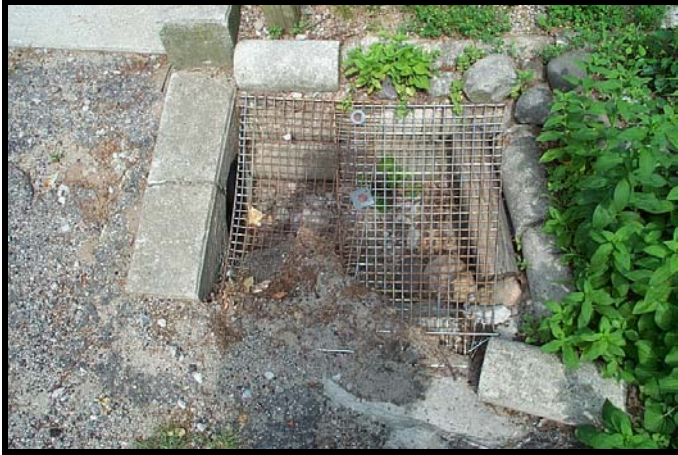
Northern grated inlet to Drain 31.

Drain 31: The drain's inlet is located at 400 EMS Lane W19. A 12-inch square grate which is partially covered with leaves, sediment, and grass clippings is located to the north of driveway. Water flows south from the grate through a 10-inch corrugated metal pipe into a 12-inch round grated inlet. This inlet also receives water from a 12-inch corrugated metal pipe which runs from the southeast underneath W19. The pipe could not be located on the southeast side of W19. Water exits the southern grated opening through two 4-inch plastic pipes and flows approximately 400 feet west towards Webster Lake. Water exits the pipes and flows approximately 25 feet as overland flow before flowing over a concrete seawall/ramp into Webster Lake.

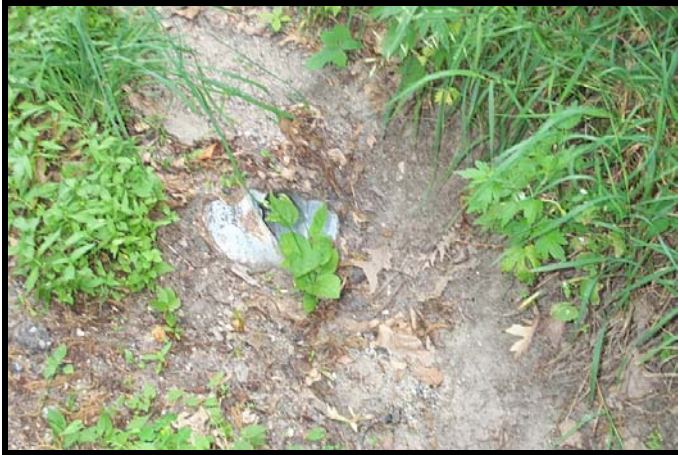
Pipe to Drain 32 which flows west underneath W17.

Drain 32: The drain is located opposite 212 EMS Lane W17. A drainage channel collects runoff from the east side of W17, directing the flow into an 8-inch corrugated metal pipe. The pipe runs west underneath W17 to a brick and concrete swale which runs 300-400 feet down the hill before reaching the lake. The pipe which runs underneath W17 is partially filled with sediment and leaves.

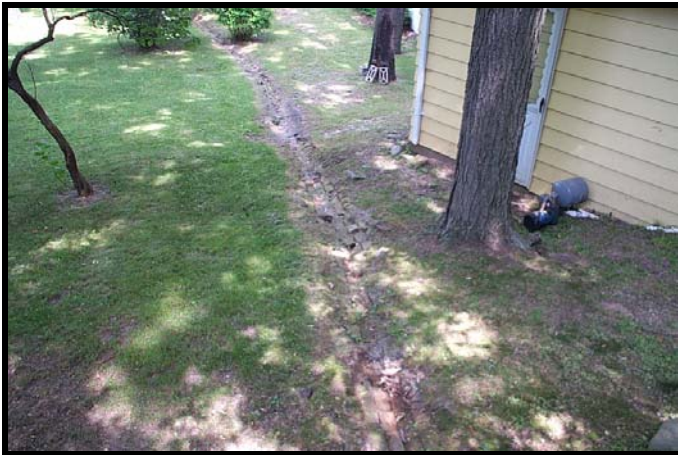
Brick and concrete swale constructed to direct water down the hill and into Webster Lake at Drain 32.

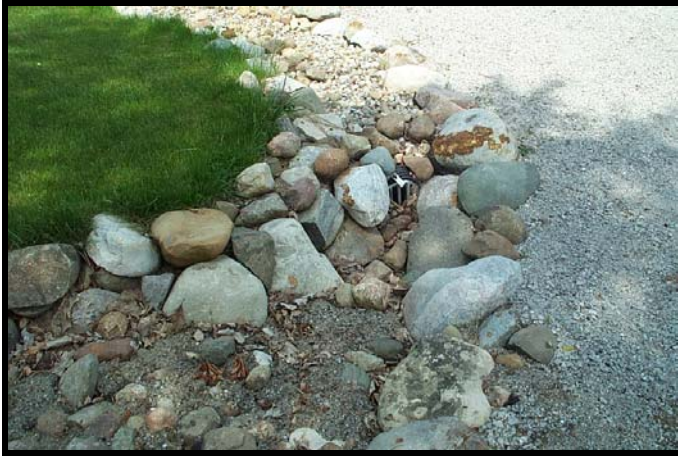
Metal grated inlet collecting water from the west side of the road at Drain 33.

Drain 33: The drain is located along the southern side of the driveway at 94 EMS Lane W17 immediately south of W17A. A drainage channel collects water east of W17. The water passes from a 10-inch circular grated opening into a 10-inch corrugated metal pipe. The pipe passes underneath W17 and runs west to an open drainage channel. The channel is defined by two rows of boulders spaced approximately one foot apart; the channel is lined with pea gravel and runs approximately 400-feet west collecting gutter and yard runoff. A 6-inch plastic perforated pipe runs underneath the drainage channel along its entire length. The pipe outlets at a 12-inch by 18-inch rectangular grated inlet. The grated inlet showed signs of disrepair and was partially filled with leaves, sediment, and debris. Another 6-inch plastic pipe carries water from this inlet approximately 50 feet west to the pipe's outlet fifteen feet from the shore of Webster Lake.

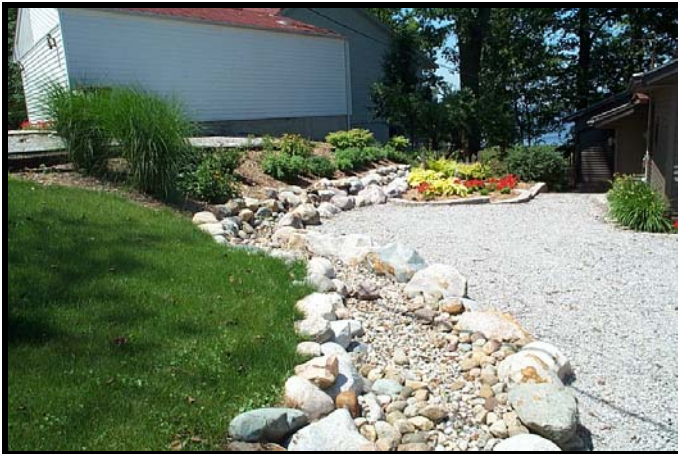
Surface drainage channel at Drain 33. A 6-inch plastic pipe runs underneath the length of the surface drain.

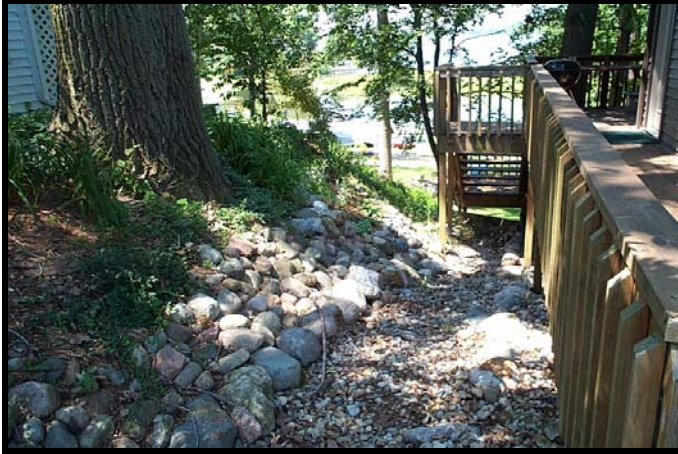
Surface and subsurface drainage channel to Drain 33.

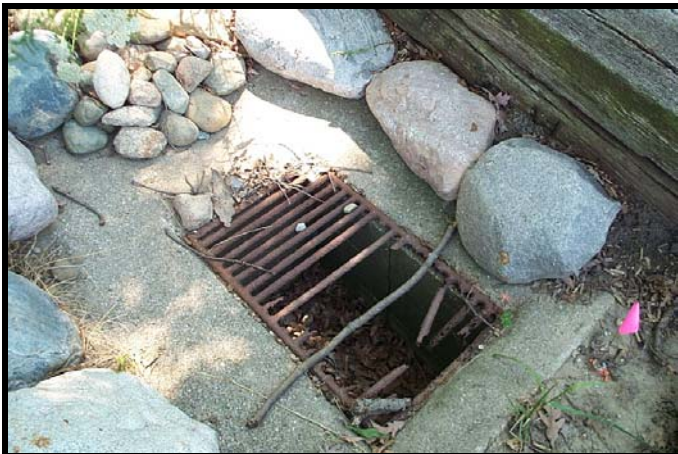
Grated inlet to Drain 33 near the lakeshore.

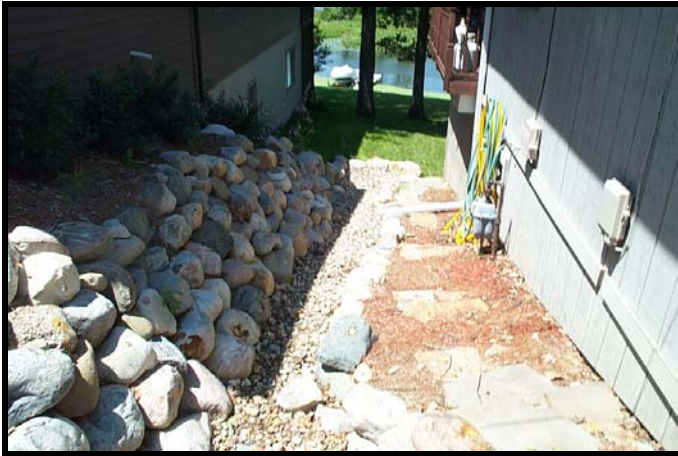
Surface and subsurface drainage channels for Drain 34.

Drain 34: This drain runs along the north side of the driveway at 94 EMS Land W17. The drain's structure is similar to that of Drain 33. The channel is defined by two rows of boulders spaced approximately one foot apart; the channel is lined with pea gravel and runs approximately 250 feet west collecting gutter and yard runoff. It is believed that a 6-inch plastic perforated pipe runs underneath the drainage channel along its entire length. The channel ends just west of the house. From here the underground pipe carries water to a 12-inch square grated inlet. Another 6-8-inch plastic pipe carries water from this inlet approximately 100 feet west to the pipe's outlet in another 10-foot long section of boulder-lined, pea-gravel filled channel at the lakeshore.

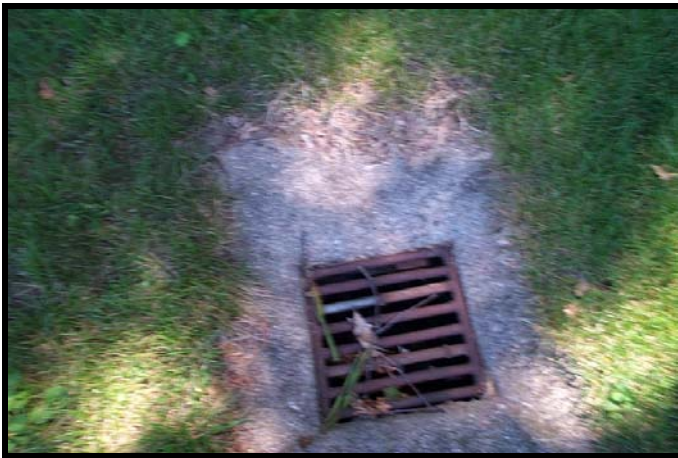
Grated inlet near the lakeshore for Drain 34.

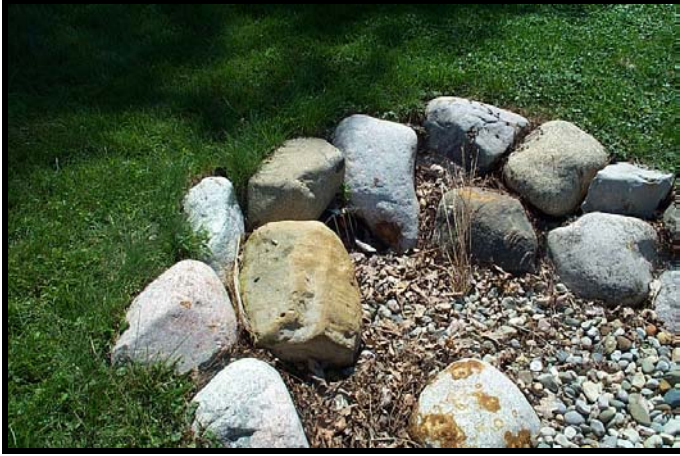
Outlet of Drain 34 at the lake.

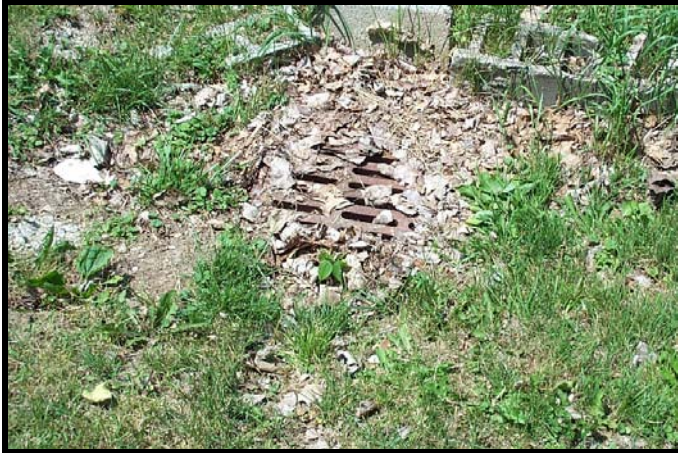
Northern grated inlet for Drain 35.

Drain 35: The drain is located at the top of the hill along EMS Lane W16A. A surface drainage channel lined with gravel collects runoff along the eastern side of the road. A 10-inch corrugated metal pipe passes underneath the road carrying water to a 14-inch round grated inlet approximately 50 feet west of W16A. The grate is partially clogged with sediment, leaves, and grass clippings; the structure below the grate is also partially clogged. Water exits the structure flowing south approximately 250 feet to a 1-foot square metal grate. A 4-6-inch plastic pipe also carries water into this structure from the south. The exact location of this pipe's origin could not be determined during the site inspection. Water exits the southern grate and travels west approximately 100 feet to a channel off of Webster Lake.

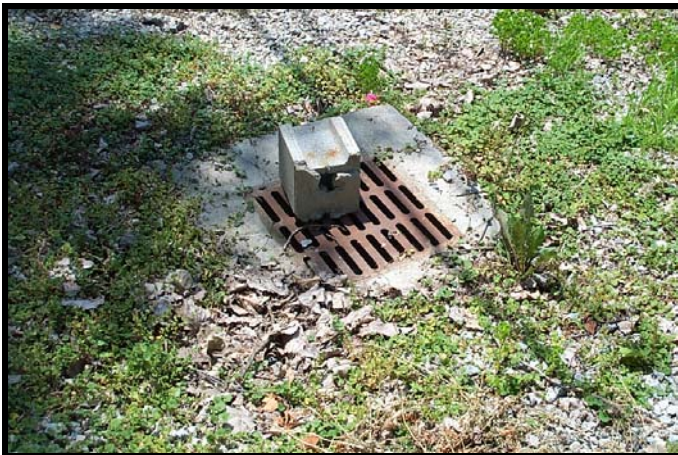
Southern grated inlet for Drain 35.

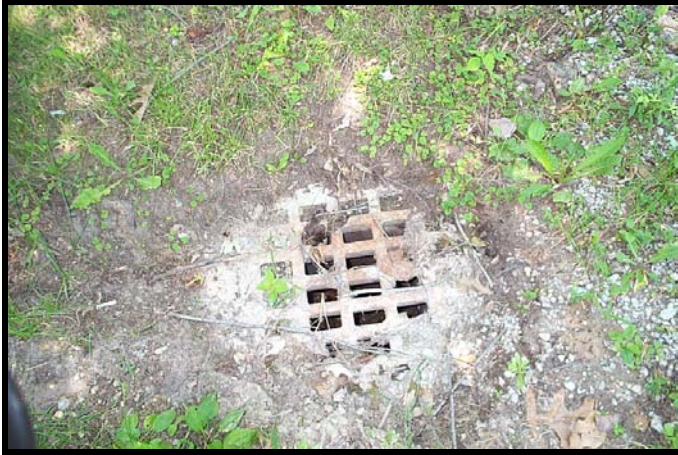
Inlet to Drain 36.

Drain 36: The drain is located at the east end of EMS Lane W16B. Water collects in a 14-inch round grated inlet adjacent to the house at the end of the road. A 12-inch clay tile carries water underneath the road approximately 400 feet to a channel connected to Webster Lake.

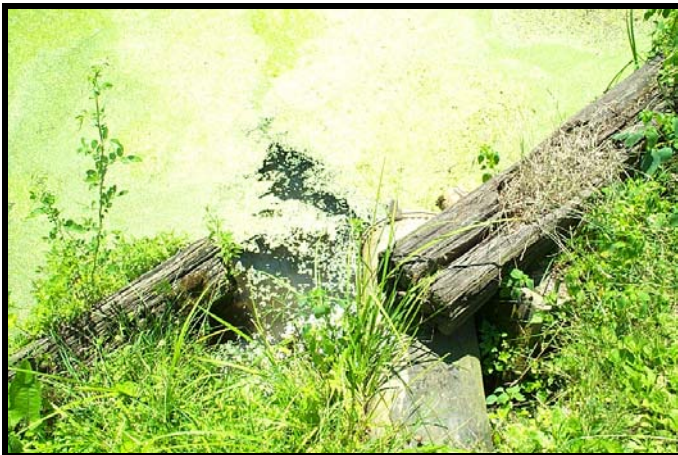
Outlet to Drain 36.

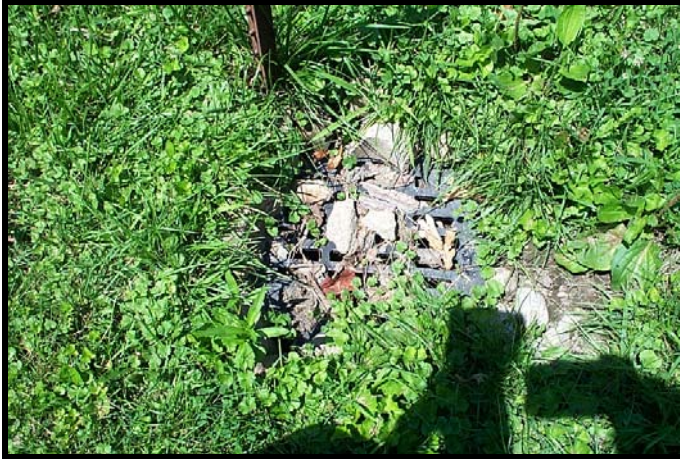
Drain 37: The drain is located at the north side of 27 EMS Lane W16B. Water collects in a 14-inch round grated inlet adjacent to the house. At the time of the survey, the inlet grate was partially clogged with leaves, grass clippings, and sediment. A 12-inch clay tile carries water south approximately 150 feet to a channel connected to Webster Lake.

Inlet to Drain 37.

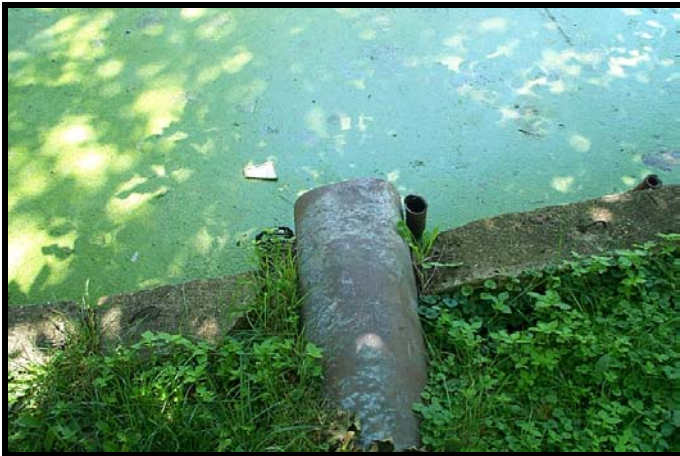
Outlet of Drain 37.

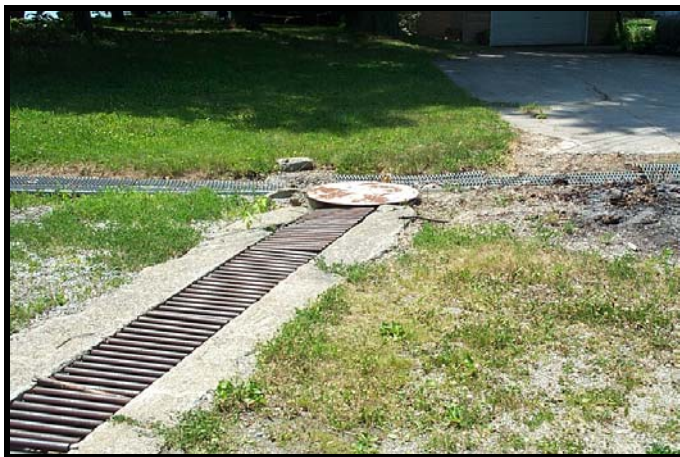
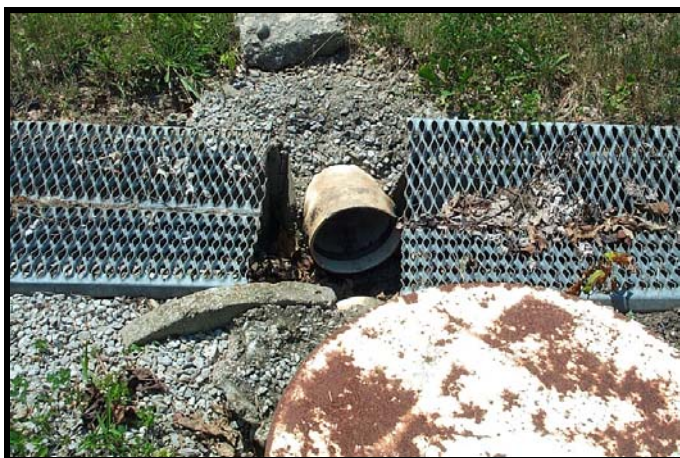
Drain 38: This drain is located at the bend in the road adjacent to the driveway for 91 EMS Lane W15. Water collects in a surface drainage ditch running from the southeast to the northwest. The surface drainage and overland flow from W15 empties into a 15-foot by 2-foot rectangular metal grate. A second 15-foot by 2-foot grate continues northwest from and roughly perpendicular to the surface drainage and crosses the driveway at 91 EMS Lane W15. Water from both the southeast and northwest travels through a dirt and gravel filled trench underneath the second grate and into a gravel filled hole. A third trench covered by a grated inlet collects water along the south side of W15; this grate is approximately 25-feet long and 2-feet wide. Water from this trench collects underneath the grate and flows through a dirt and gravel trench into the gravel filled hole. Another 6-inch plastic pipe carries water into the drain from the east; the exact location of this pipe's origin could not be located at the time of the survey. Water from these four sources exits the drain through a 10-inch plastic pipe which flows 150 feet west toward Webster Lake. The pipe ends approximately 50 feet east of the lake; from this point, water flows through an area of bare ground, across a sparsely grassed area, over a concrete seawall, and into Webster Lake. A second pipe exits the seawall approximately 15 feet north of where overland flow carries water into the lake. This pipe may have originally been connected to the drain network; this could not be determined at the time of the field survey.

Drain structure at Drain 38.

Pipes entering and exiting Drain 38.

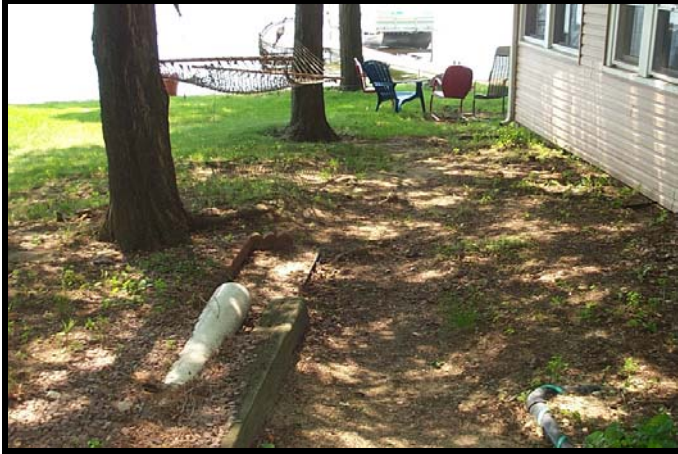
Outlet pipe from Drain 38; water flows from here approximately 50 feet to Webster Lake.

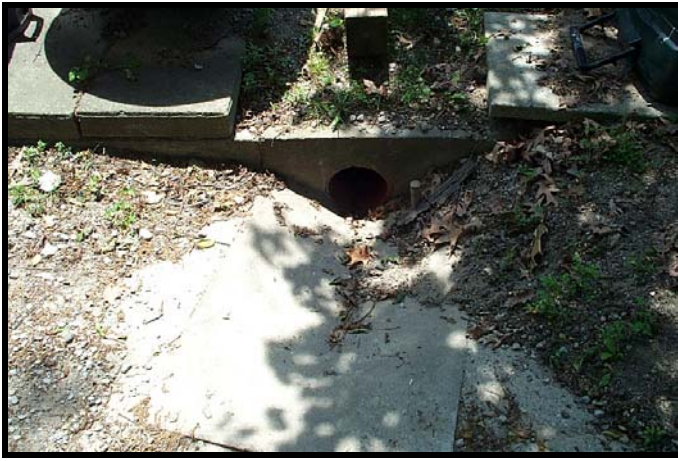
Entrance pipe for Drain 39 in concrete depression.

Drain 39: The drain's inlet is located at the top of the hill on the north edge of the cement driveway leading to 41 EMS Lane 14B. (B might not be correct; check this address.) Water from the road and adjacent yards pools in the cement depression located at the north edge of the driveway. A 6-inch clay pipe carries water from the depression west towards Webster Lake. A series of two parallel 6- and 10-inch clay pipes and a 12-inch plastic pipe carry water 400 feet to the lake. The exact pipe that carries water to the lake could not be determined at the time of the survey. Evidence of overland flow and erosion of the hillside was present at the time of the survey. It is believed that a portion of the original clay pipe has been replaced by the plastic pipe at some point along the route to the lake. Water flows from a 6-inch plastic pipe through a concrete seawall and into the lake.

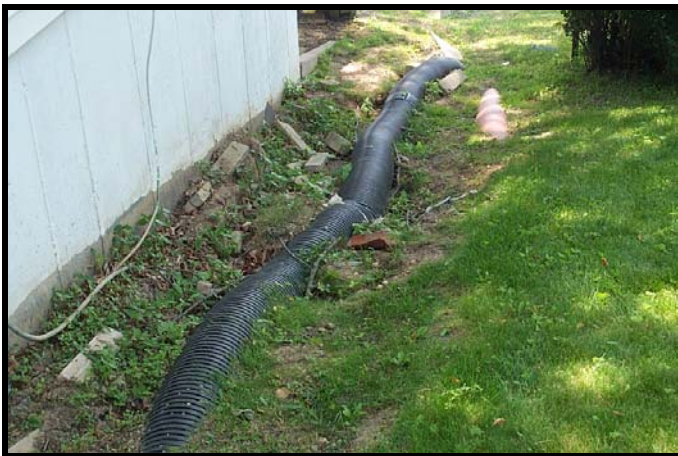
Series of pipes at Drain 39 which convey water down hill toward Webster Lake.

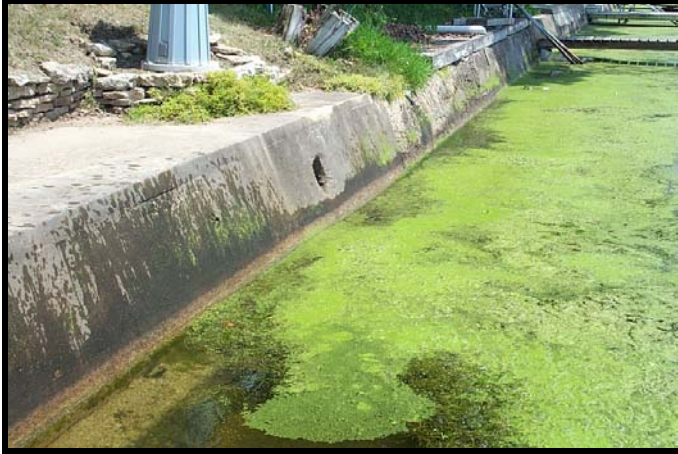
Outlet at Webster Lake for Drain 39.

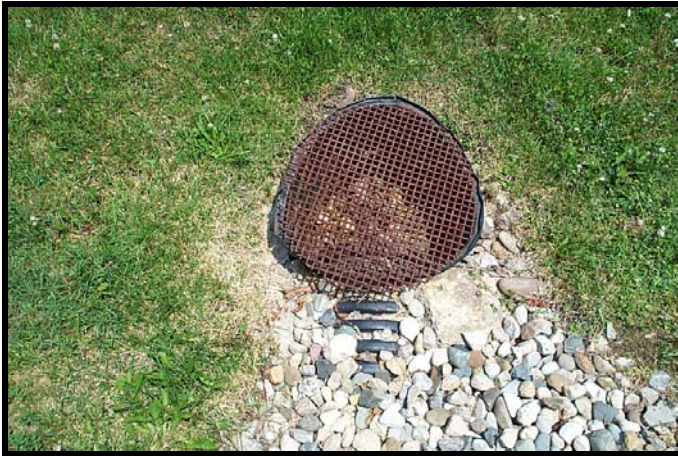
Plastic pipe and grated inlet at Drain 40.

Drain 40: Drain 40 is located adjacent to the west parking lot of the Echo Bay Condominiums along the north shore of Webster Lake. Water from the condominium parking lot is directed from the west edge of the parking lot into a stone-lined infiltration trench. Water drains from the trench into a 10-inch plastic pipe which runs east towards the building. The pipe drains into a 12-inch circular grated inlet lined with gravel. It is believed that the pipe continues southwest towards the lake; however, an outlet pipe along the lakeshore was not found at the time of the survey. It is likely that the pipe ends somewhere between its origin near the parking lot and the lawn leading to the lakeshore.

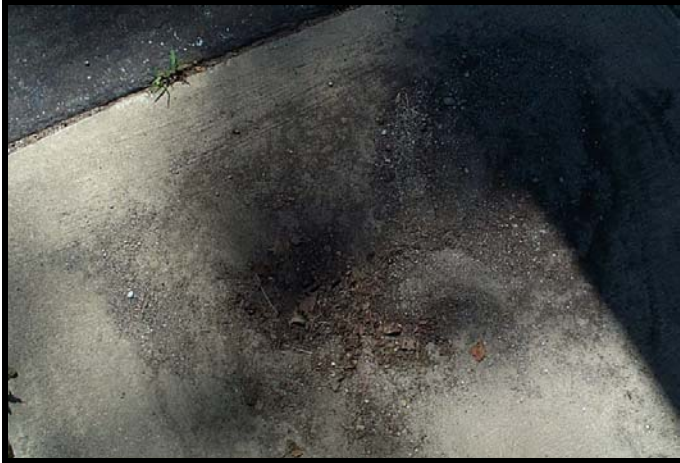
Inlet to Drain 41.

Drain 41: The inlet to Drain 41 is located in the driveway immediately west of the house at 6527 Wade Lane. A 6-inch square grated inlet drains water to a 4-inch plastic pipe. The grate was completely covered by sediment at the time of the survey. The pipe runs south approximately 50 feet through a concrete seawall and outlets at Webster Lake.

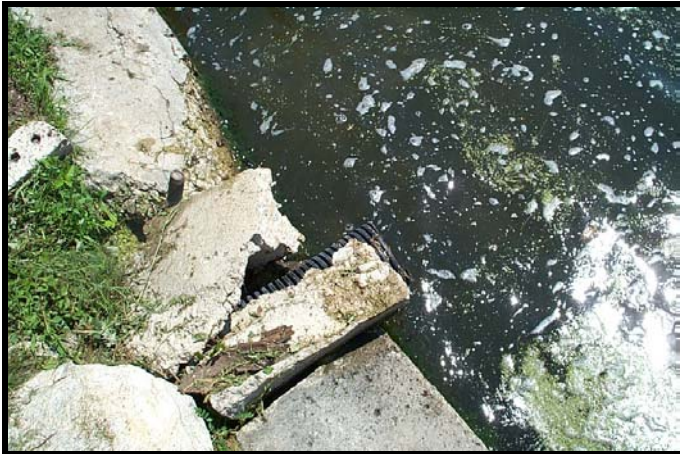
Outlet from Drain 41.

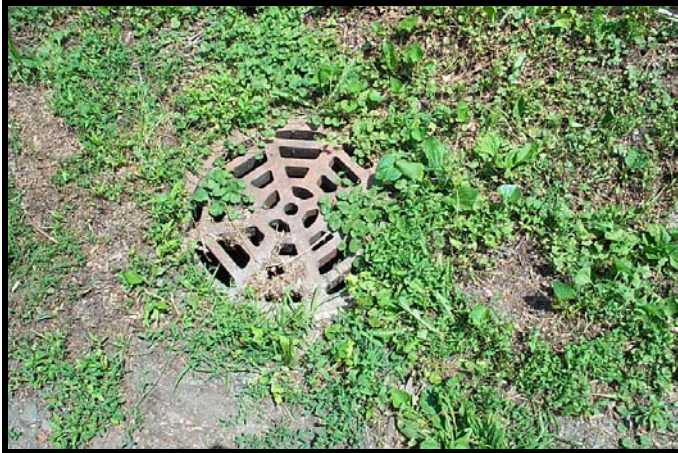
Grated inlet to Drain 42.

Drain 42: This drain is located opposite 8501 Wesley Lane at the northeast corner of 9th Trail and Wesley Lane. The drain's inlet cover is a 14-inch circular grate located in a yard adjacent to the road. A 12-inch plastic pipe enters the drain from the north draining water from 9th Trail. The origin of this pipe was not located at the time of the survey. The structure of the drain consists of a 14-inch corrugated metal pipe placed perpendicular to the ground's surface, which appears to be free of debris. Water exits the drain through a 12 inch plastic pipe which travels south underneath Wade Lane approximately 300 feet to Webster Lake.
